**United States Environmental Protection Agency
Criminal Investigation Division
Investigative Activity Report**

Fortymile: [REDACTED] Placer Mine Investigation (APMA
[REDACTED])

Mine Discharge Investigation at the APMA [REDACTED] Mine 08-22-13

Mine Discharge Investigation at the APMA [REDACTED] [REDACTED] Mine (08/22/13)

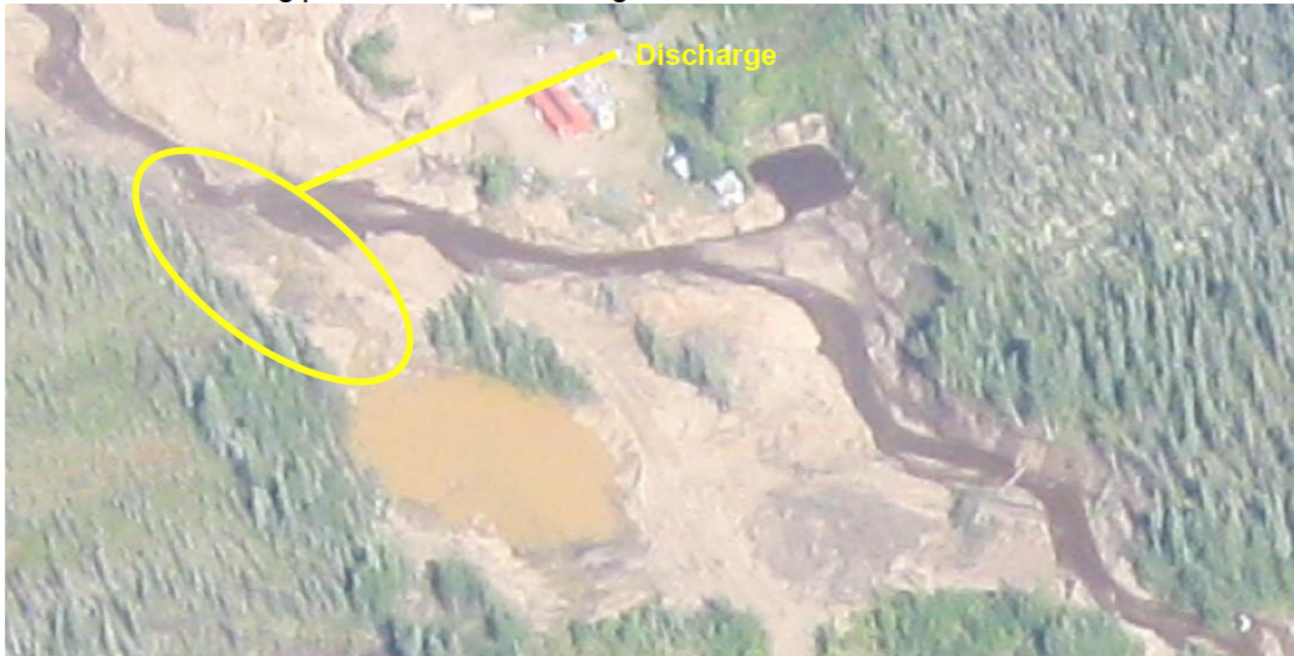
Photograph 1 was taken from the aircraft by Special Agent [REDACTED] on 08/19/13 at approximately 2:31PM and depicts an apparent discharge from the mine's final settling pond into Canyon Creek. Reference IMG0011.

Photo 1: Final settling pond with turbid discharge into creek on 08/19/13.

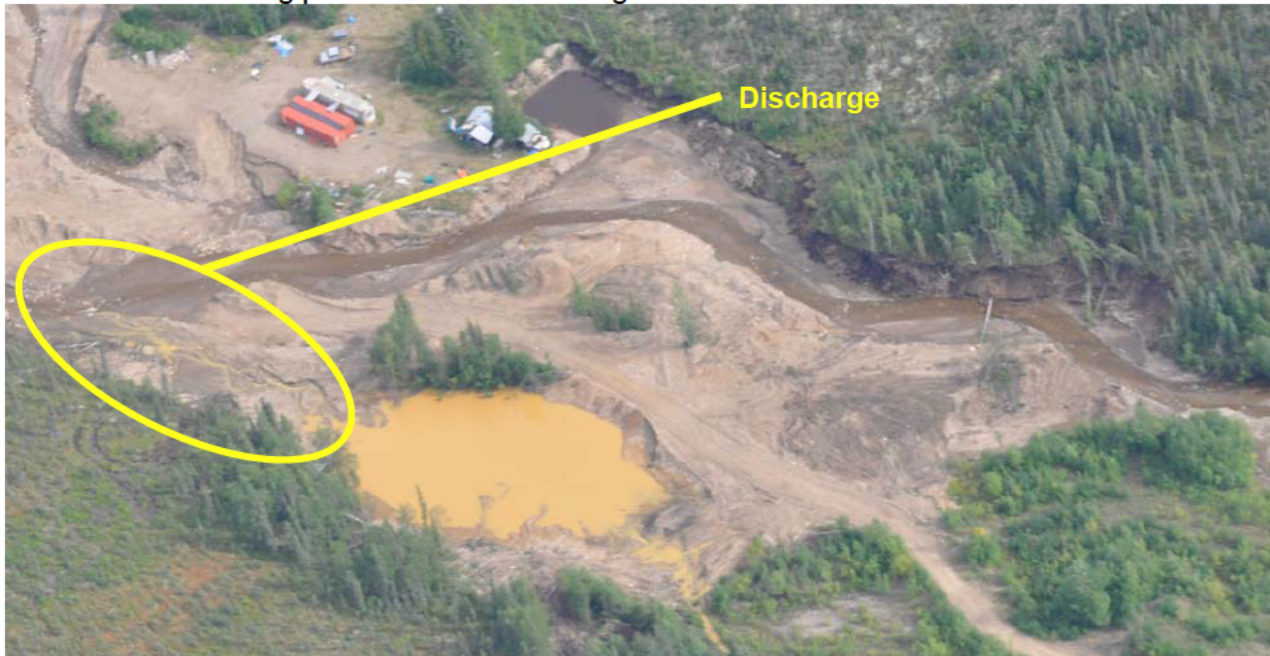
Photograph 2 was taken by Special Agent [REDACTED] on 08/20/13 at approximately 12:40PM and depicts an apparent discharge from the mine's final settling pond into Canyon Creek. Reference DSC0090.

Photo 2: Final settling pond with turbid discharge into creek on 08/20/13.

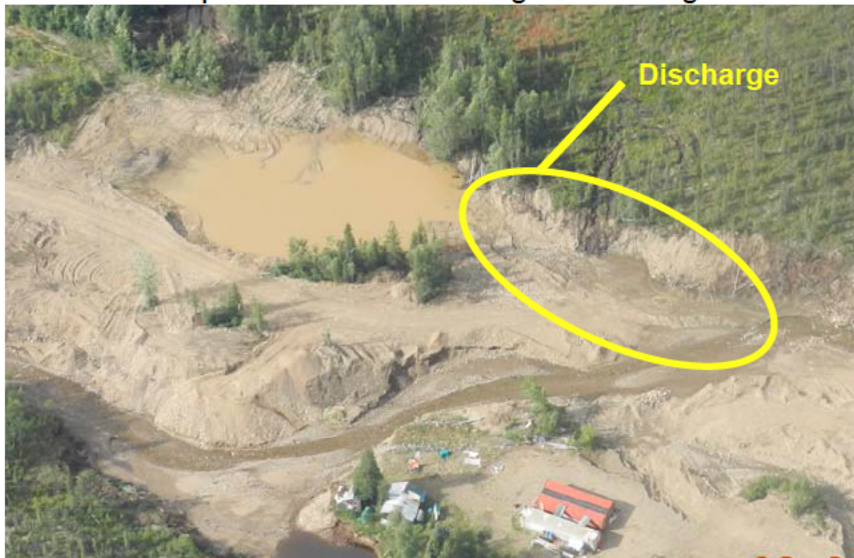
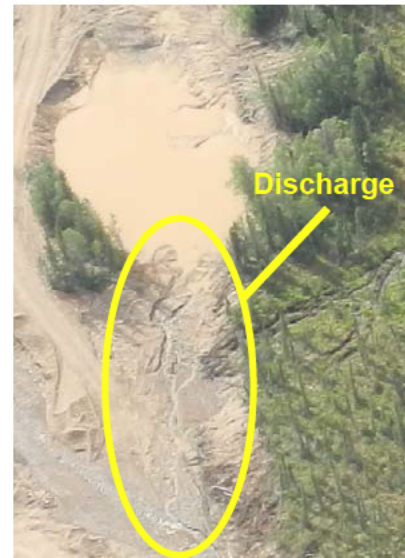
Photograph 3 and **Photograph 4** were taken by Special Agent [REDACTED] on 08/22/13 at approximately 11:51AM and depict an apparent discharge from the mine's final settling pond into Canyon Creek. Reference DSCN1618 and DSCN1616.

Photo 3: Final pond with turbid discharge on morning of 08/22/13. **Photo 4:** Same as Photo 3.

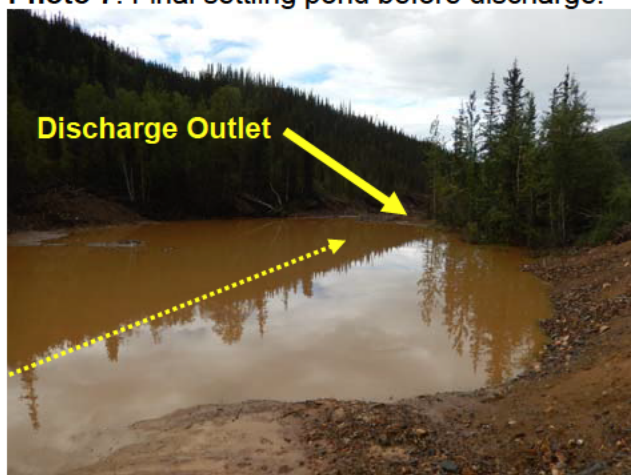
Photo 7: Final settling pond before discharge.

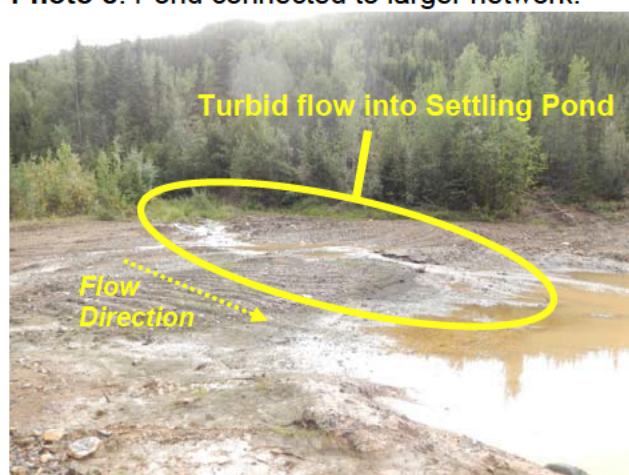
Photo 8: Pond connected to larger network.

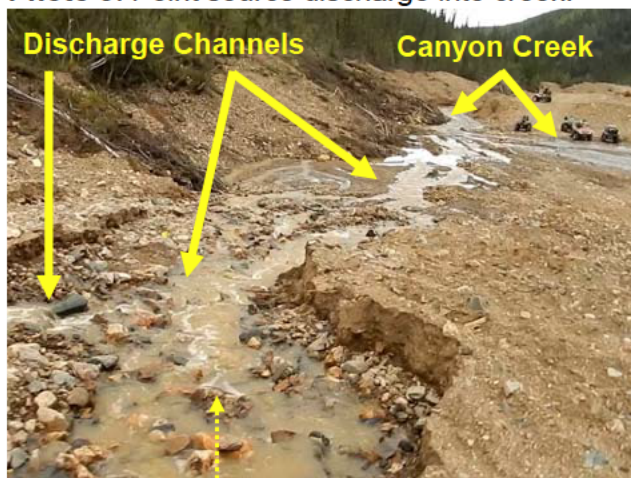
Photograph 9 and **Photograph 10** are excerpts from video DSCN0825 taken by Special Agent [REDACTED] at approximately 5:12PM and depict multiple channels discharging turbid effluent from the settling pond into Canyon Creek. The ATVs in the picture belong to the investigative team and are parked along the gravel road.

Photo 9: Point source discharge into creek.

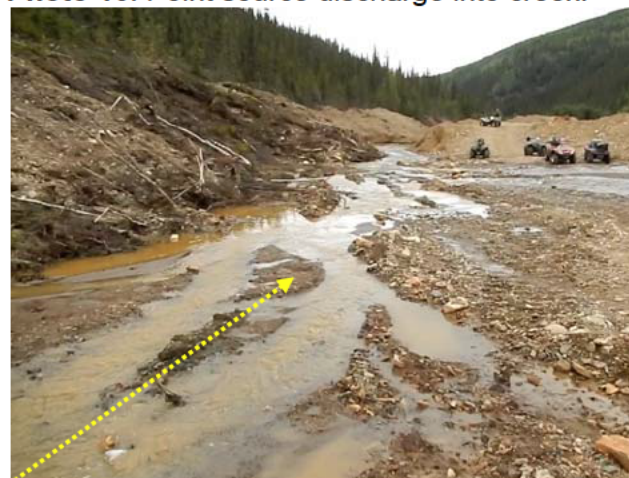
Photo 10: Point source discharge into creek.

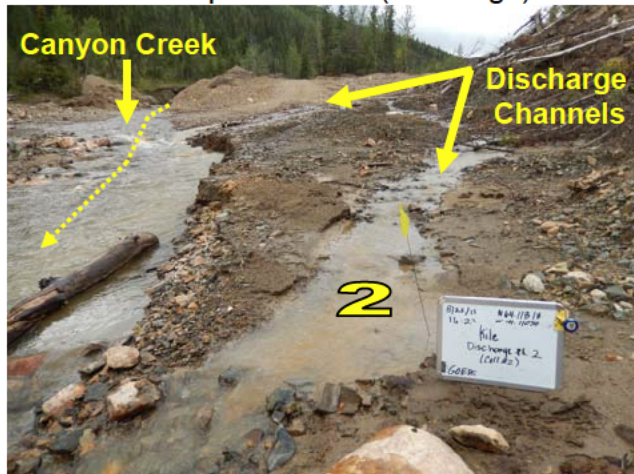
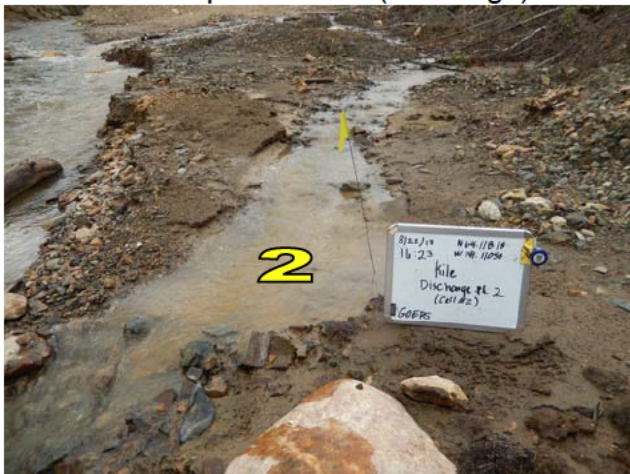
Photo 12: Sample Station 2 (Discharge).

On 08/22/13 at approximately 4:32PM, Special Agent [REDACTED] collected a sample of effluent from one of the discharge channels and designated it **Sample 2**.⁷ The sample cell was filled directly from the discharge channel as it flowed from the settling pond and immediately before entering the creek. As reported in Section 11 of this report, discharge **Sample 2** resulted in a reading of 196 NTUs.

Photograph 12 and **Photograph 13** were taken by Special Agent [REDACTED] on 08/22/13 at approximately 4:33PM and depict the source location for the collection of a discharge sample from **Sample Station 2**. Additional discharge channeling from the settling pond (not visible in these pictures) can be seen in the background as well as the impacted Canyon Creek receiving stream.

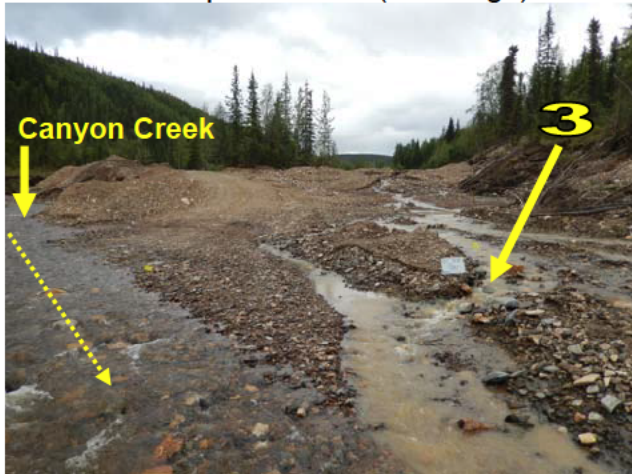
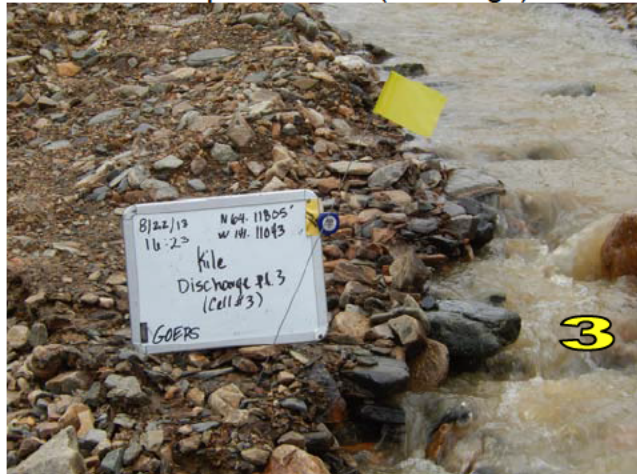
Photo 14: Sample Station 3 (Discharge).

On 08/22/13 at approximately 4:34PM, Special Agent [REDACTED] collected a sample of effluent from another of the settling pond's discharge channels and designated it **Sample 3**.⁸ The sample cell was filled directly from the discharge channel as it flowed from the pond and immediately before entering the creek. As reported in Section 11 of this report, discharge **Sample 3** resulted in a reading of 253 NTUs.

into the clear water of Canyon Creek. Turbidity monitoring in Canyon Creek upstream of the discharge was conducted and is reported in Section 11 of this report.

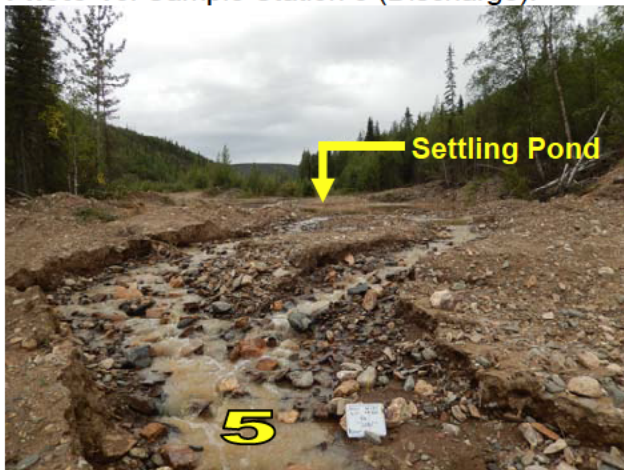
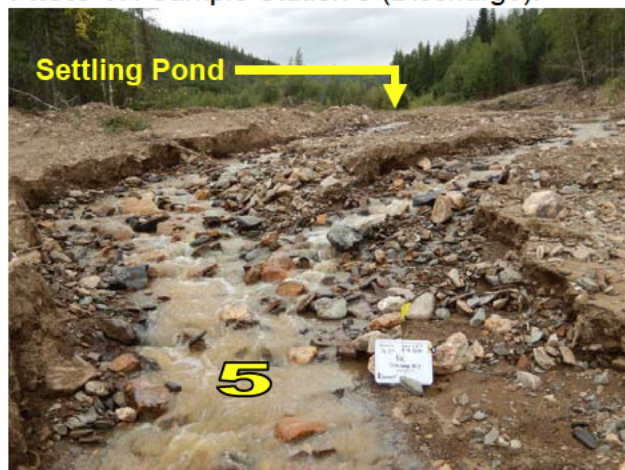
Photo 16: Sample Station 5 (Discharge).

On 08/22/13 at approximately 4:44PM, Special Agent [REDACTED] collected a sample of effluent in a main channel from the settling pond's discharge and designated it **Sample 5**.⁹ The sample cell was filled directly from the discharge channel as it flowed from the pond. As reported in Section 11 of this report, discharge **Sample 5** resulted in a reading of 283 NTUs. **Photograph 16** and **Photograph 17** were taken by Special Agent [REDACTED] on 08/22/13 at approximately 4:44PM and depict the source location for the collection of a discharge sample from **Sample Station 5**.

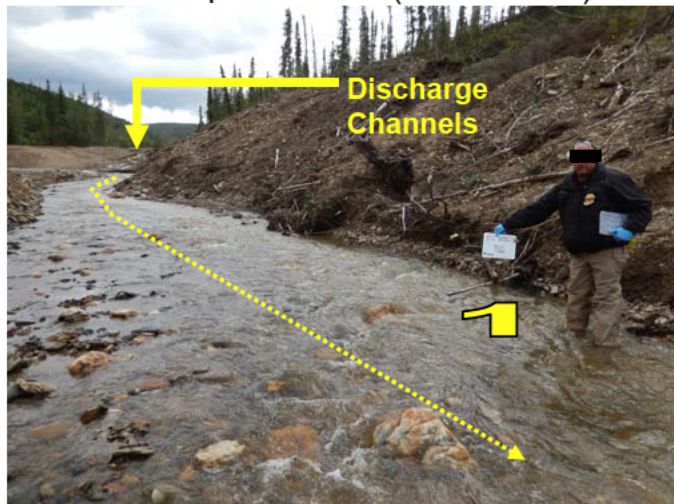
Photo 18: Sample Station 1 (Downstream)

It was observed that as the discharged effluent entered Canyon Creek and mixed with the larger volume of clear creek water, a visibly turbid effluent plume remained and impacted the creek. Special Agent [REDACTED] identified two sample stations in Canyon Creek downstream of the discharge and monitored turbidity from each station. No other sources of turbid water were observed entering Canyon Creek between the discharge points into Canyon Creek and the downstream sample stations.

Photograph 18 was taken by Special Agent [REDACTED] on 08/22/13 at approximately 4:26PM and depicts the source location for the collection of a downstream creek sample from **Sample Station 1**. The person appearing in the photograph is Special Agent [REDACTED] identifying the referenced sample station's location.

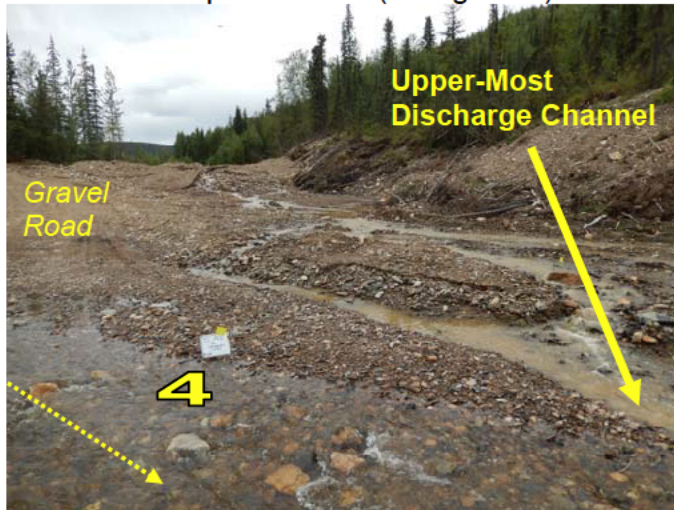
Photo 22: Sample Station 4 (Background)

¹² The APDES General Permit places **Limitations & Monitoring Requirements** for turbidity discharges at an instantaneous maximum of no more than "5 NTUs above natural conditions." APDES General Permit [REDACTED] Sec. 2.0.

On 08/22/13 at approximately 4:36PM, **Sample Station 4** was monitored in Canyon Creek approximately 20 feet upstream from the upper-most discharge channel, where the settling pond's effluent discharged into the creek creating a turbid plume.¹³ The sample cell was filled directly from the creek. As reported in Section 11 of this report, background **Sample 4** resulted in a reading of 1.89 NTUs.

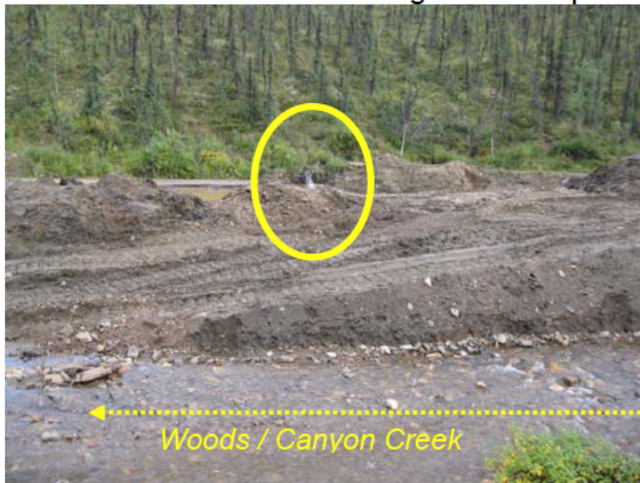
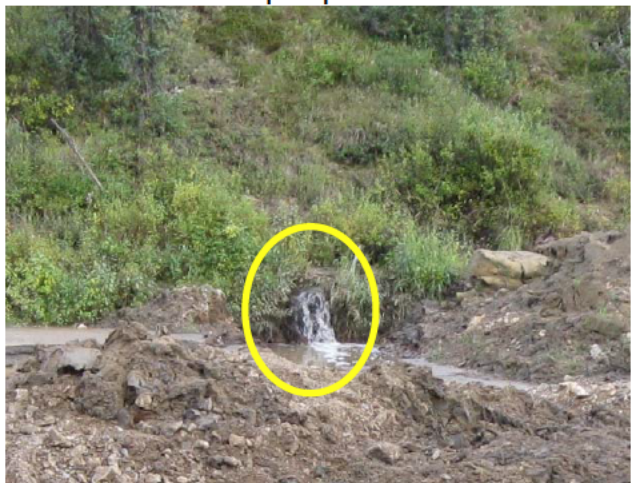
On 08/22/13, investigators at the mine site observed multiple examples of surface water and/or drainage water entering into the mine's extended network of interconnected turbid settling ponds and ditches.¹⁹ In addition, as reported in a separate Investigative Activity Report (IAR) referencing audio recorded statements made by [REDACTED] to investigators on 08/22/13, [REDACTED] confirmed his knowledge of surface waters draining into his settling ponds. This knowledge includes what [REDACTED] described as a *"little crick"* that feeds into *"that lower pond."*²⁰

Photograph 28 is a closer perspective of Photograph 27, depicting the surface flow into the settling pond. Reference IMG616.

Photo 27: Surface water flowing into turbid ponds. **Photo 28:** A closer perspective.

¹⁹ The General Permit requires a permittee to follow **Best Management Practices (BMP)** which specify that "[t]he flow of surface waters into the plant site shall be interrupted and these waters diverted around and away from incursion into the plant site. APDES General Permit [REDACTED] Sec. 3.2.1.

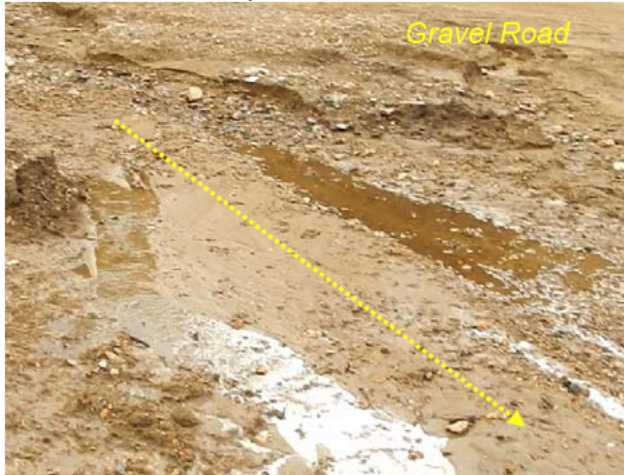
Photograph 29 represents a frame from video recording DSCN2494 taken by EPA Special Agent [REDACTED] on 08/22/13 at approximately 5:30PM. This photograph depicts the apparent emergence of clear flowing water to the surface along the gravel road which runs parallel to Woods / Canyon Creek. This clear flowing surface water was observed and video recorded flowing directly into the mine's turbid network of settling ponds and ditches.

Photo 29: Water emerges and flows across surface into turbid pond and ditch network.

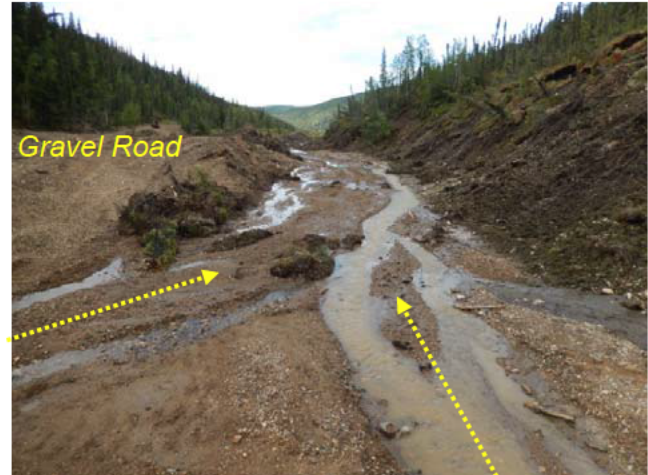
Photograph 30, also taken by Special Agent [REDACTED] at approximately the same time, depicts the confluence of the clear flowing surface water into the turbid settling pond and ditch network.²¹ Reference DSCN2493.

Photo 30: Surface water flows into turbid ditch network.

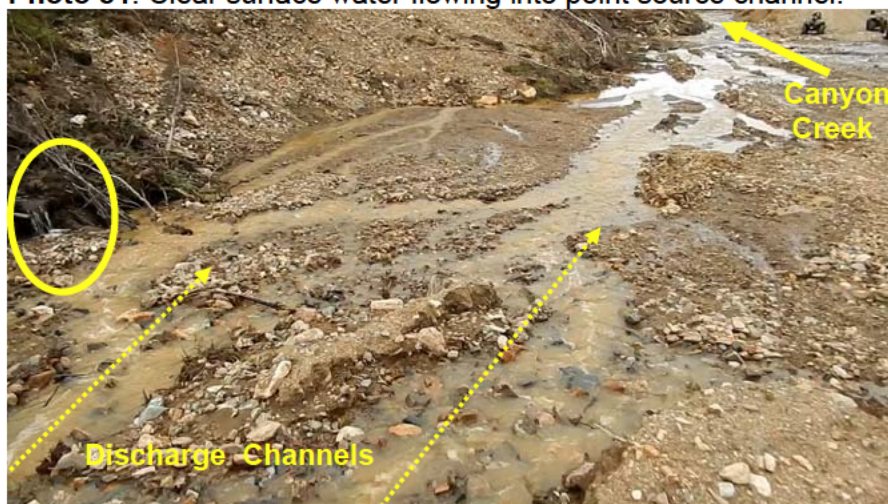
Photograph 31 represents a frame from video recording DSCN2448 taken by EPA Special Agent [REDACTED] on 08/22/13 at approximately 4:45PM. This frames depicts clear surface water flowing directly into the mine's point source channels, previously referenced in conjunction with **Sample Stations 2, 3, and 5**. The introduction of this surface water drainage occurred downstream from the mine's final settling pond and immediately prior to the channels' discharge into Canyon Creek.

Photo 31: Clear surface water flowing into point source channel.

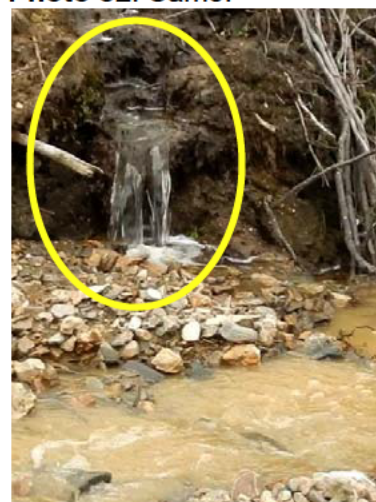
Photograph 32 represents a frame from the same video recording and provides a closer perspective of the clear surface water flowing into the turbid discharge channel.

Photo 32: Same.

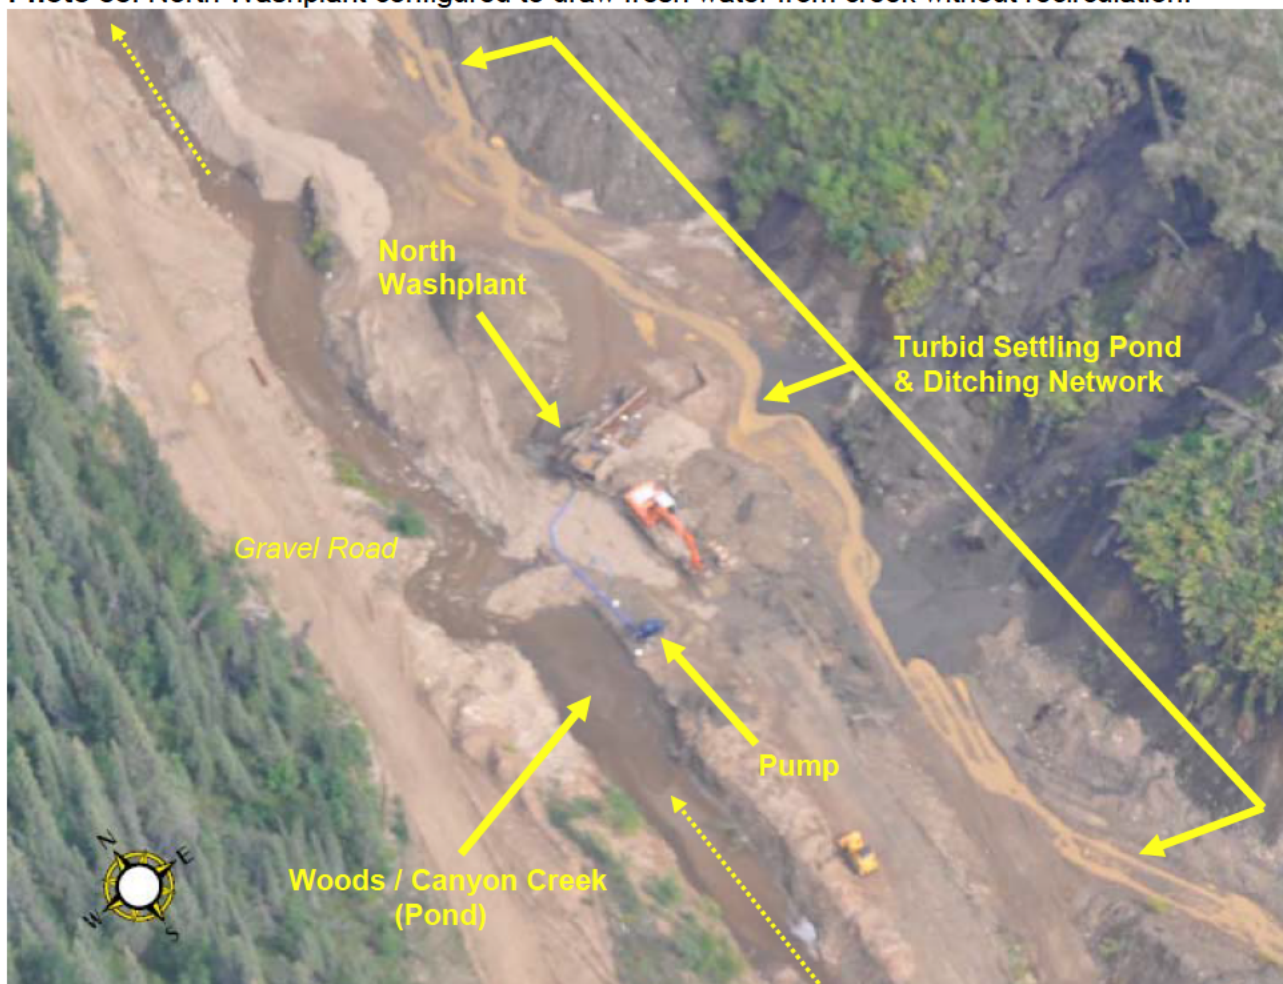
Photograph 33 was taken by Special Agent [REDACTED] on 08/20/13 at approximately 12:39PM and depicts the North Washplant situated adjacent to a dammed portion of Woods / Canyon Creek. To the west of the washplant is Woods / Canyon Creek, flowing northward. To the east of the washplant is a continuation of the mine's turbid settling pond & ditching network, also flowing northward. Located upstream in the turbid ditching network is the South Washplant. Reference DSC0083.

Photo 33: North Washplant configured to draw fresh water from creek without recirculation.

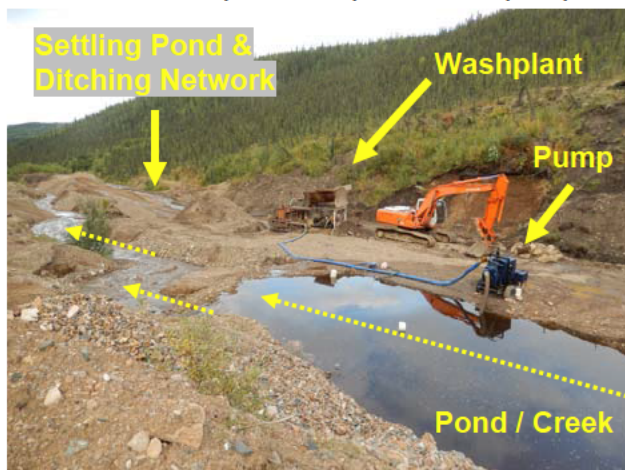
Photograph 34 was taken by EPA Special Agent [REDACTED] on 08/22/13 at approximately 5:55PM and depicts a ground level perspective of the North Washplant adjacent to a dammed portion of Woods / Canyon Creek. Visible in the photo is a pump with a hose resting in the pond. A longer blue-colored hose leads from the pump to the washplant.

Photo 34: Washplant and pond water pump.

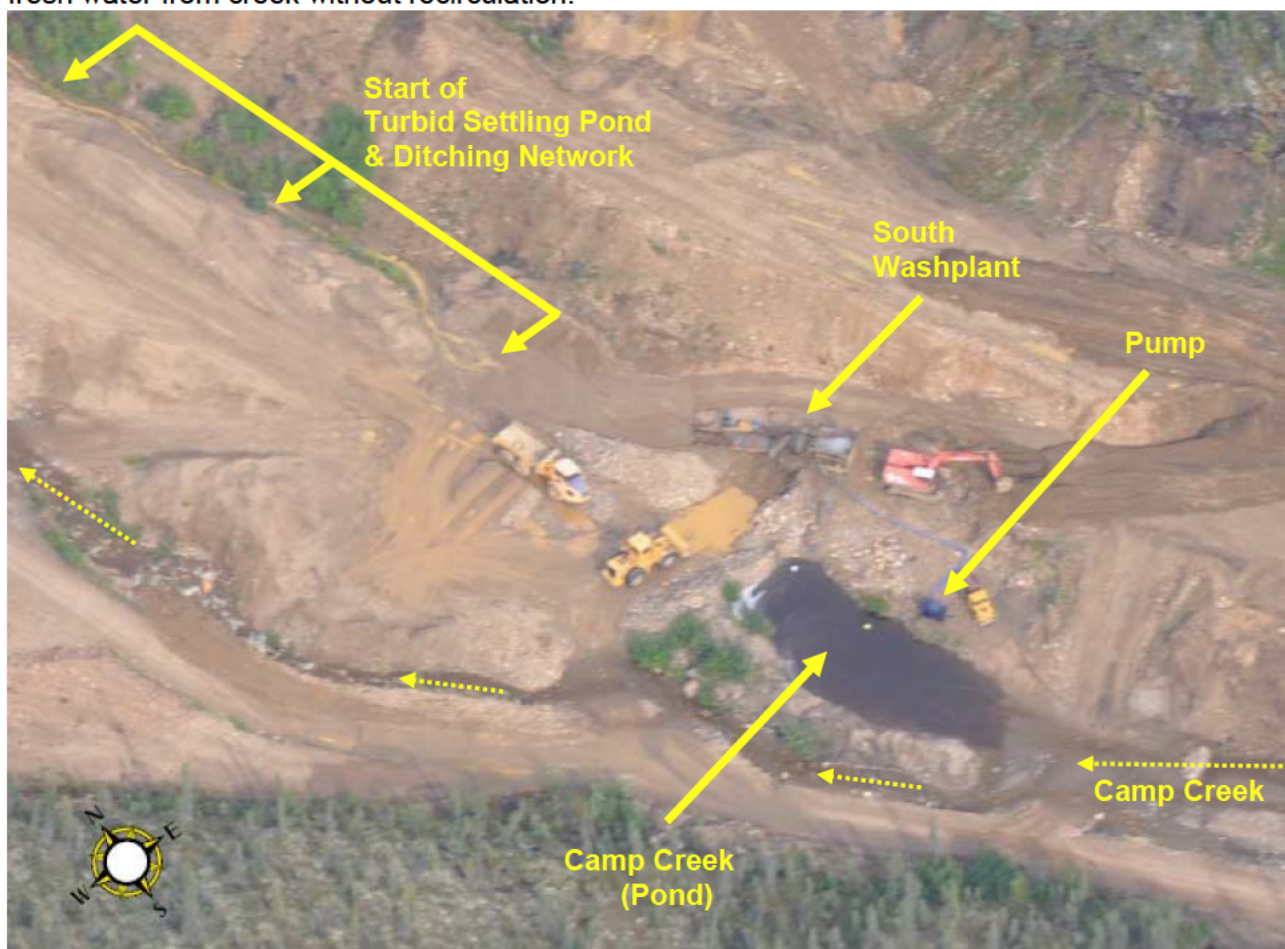
Photo 36: South Washplant (start of turbid settling pond & ditching network) configured to draw fresh water from creek without recirculation.

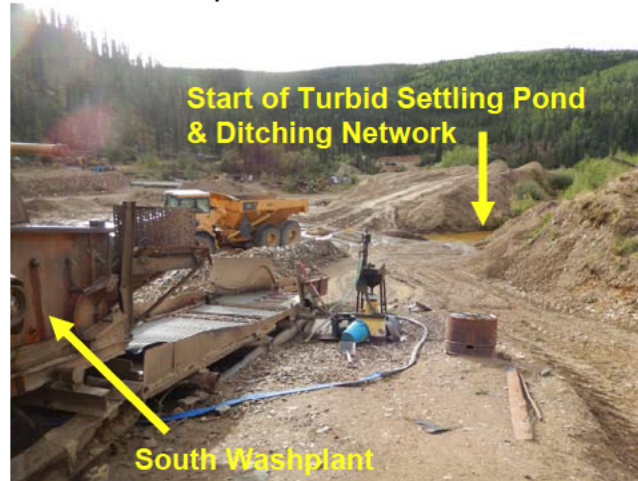
Photo 38: Washplant & start of turbid network.
